Inspection Report

Property Address:
12345 FANTASYLAND STREET
ANAHEIM CA 99999

Home Inspection Detection Services

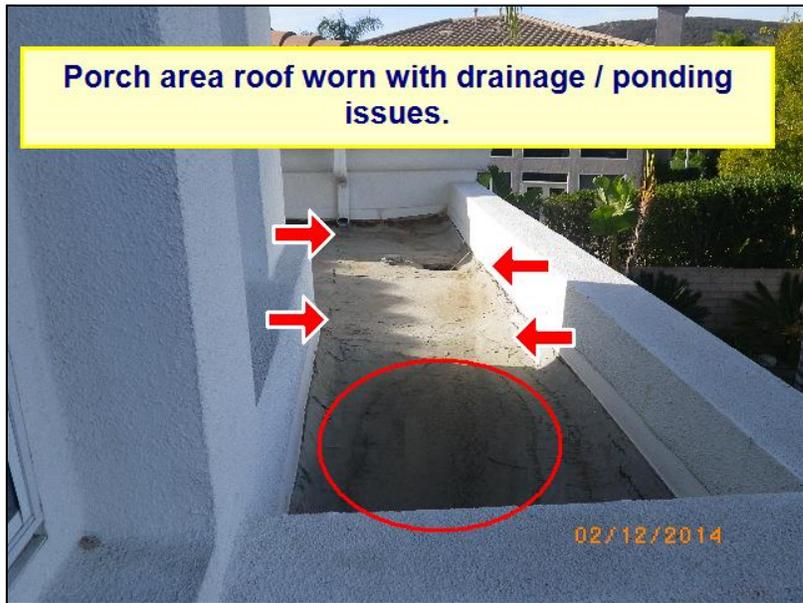
1.0 Item 1(Picture)

1.0 The main upper, main lower and garage roof were all in serviceable condition. However, porch area roof has moderate wear and deterioration along with evidence of ponding of water and or inadequate drainage. Further evaluation and or inspection is advised by a licensed roofer.

The main upper, main lower and garage roof were all in serviceable condition. However, porch area roof has moderate wear and deterioration along with evidence of ponding of water and or inadequate drainage. Further evaluation and or inspection is advised by a licensed roofer.

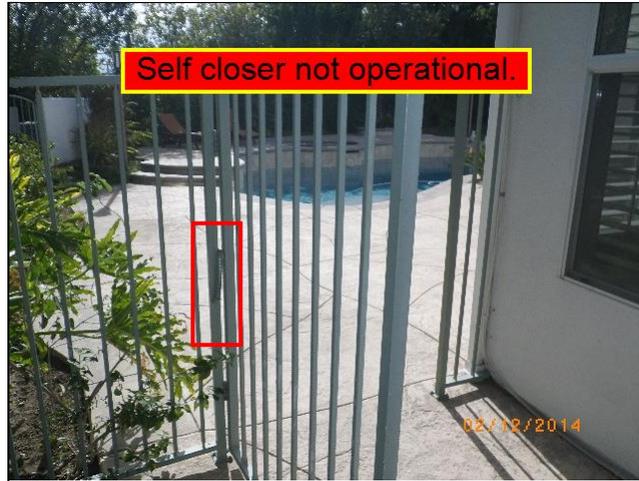
2.3 Item 1(Picture)

2.3 Left side wrought iron gate has a non functional self closing device. This device is required to be installed and operational due to pool / spa install. This is a safety concern / hazard.

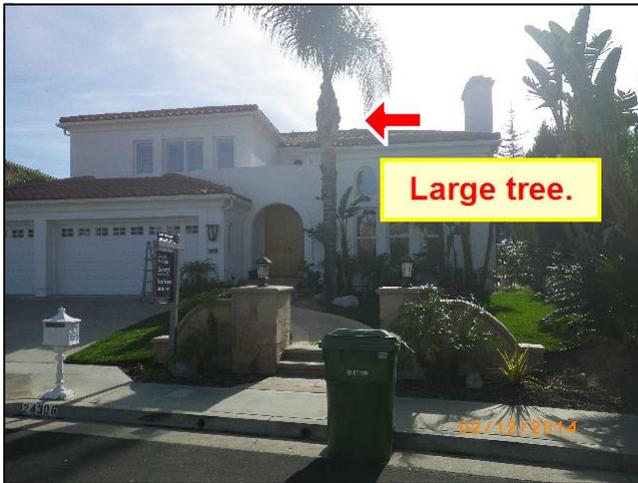
2.4 Item 1(Picture)

- Large tree was planted at the front of the property. Although no readily visible problem was noted, monitoring, due to the size is recommended.
- Block walls have moderate cracks at various locations and please note that large trees are planted close to and or in contact with the block walls at the left side of the home.

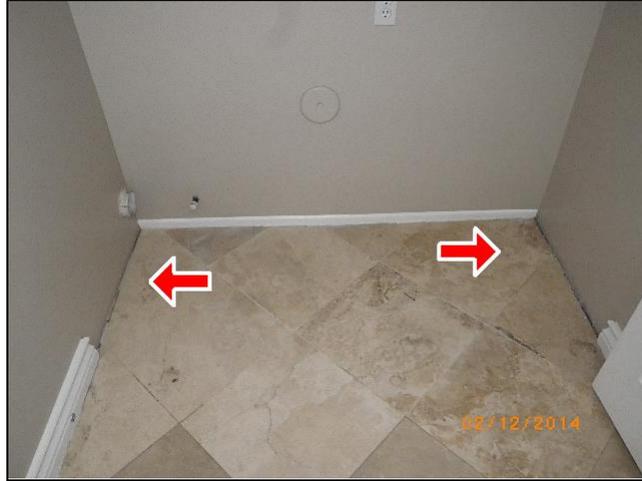
4.3 Item 1(Picture)

4.3 Floor baseboards / trim was missing at the laundry area. This has been purposely done to accommodate washer and dryer.

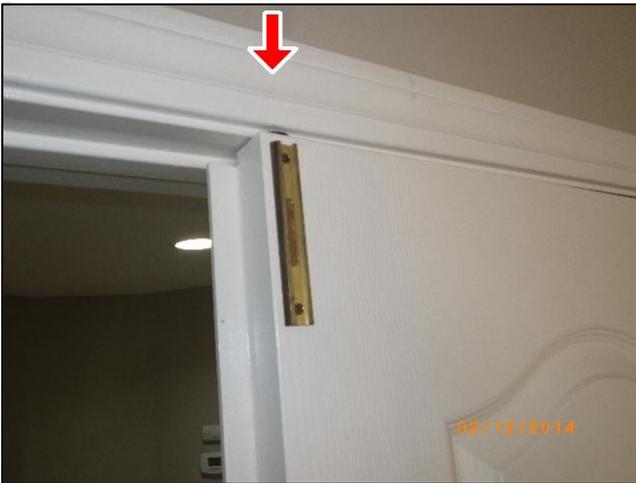
4.5 Item 1(Picture)

- Master bedroom entry door has missing latching hardware.
- Please note that many bedroom entry doors have a unique child safety mechanism installed. This, although made to have entry doors child proof and unable to be opened is not actually safe. Child may be unable to open from inside the bedroom due to height and unable to get out of the room.. this is a safety concern / hazard.

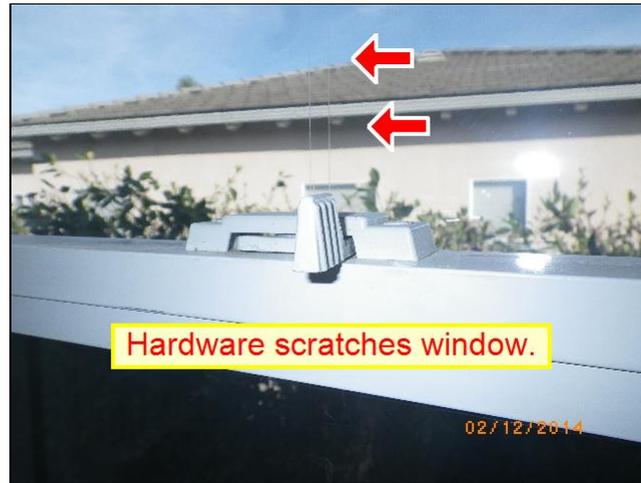
4.6 Item 1(Picture)

- Many of the windows in the home were difficult to operate.
- Various windows throughout the home had defective mechanism that keeps windows open.
- Various windows appeared to be scratched due to window hardware.
- Front facing window in bedroom 3 does not latch / close properly.

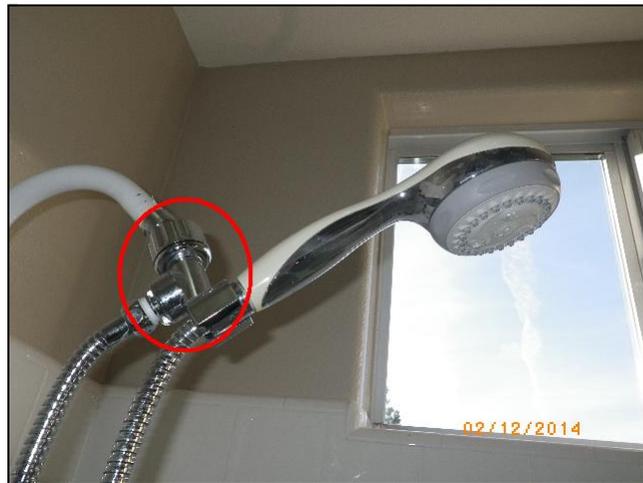
6.1 Item 1(Picture)

6.1 Both the master bathroom and bedroom 2 bathroom have leaking shower heads.

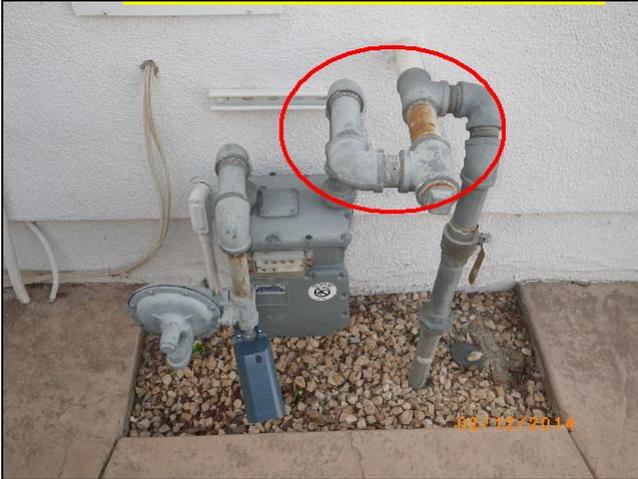
6.4 Item 1(Picture)

- Gas line to both of the heating systems in the attic area lack proper support. This is a safety hazard / concern. Repair is needed by a licensed HVAC contractor or licensed plumber.
- Vent pipe to heating system to the upstairs area lacks proper clearance from combustibile material. This is a safety hazard / concern. Repair is needed by a licensed HVAC contractor or licensed plumber.
- Seismic gas shutoff valve was not installed to the gas meter. This installation is a requirement. This is a safety hazard / concern. Repair is needed by a licensed HVAC contractor or licensed plumber.

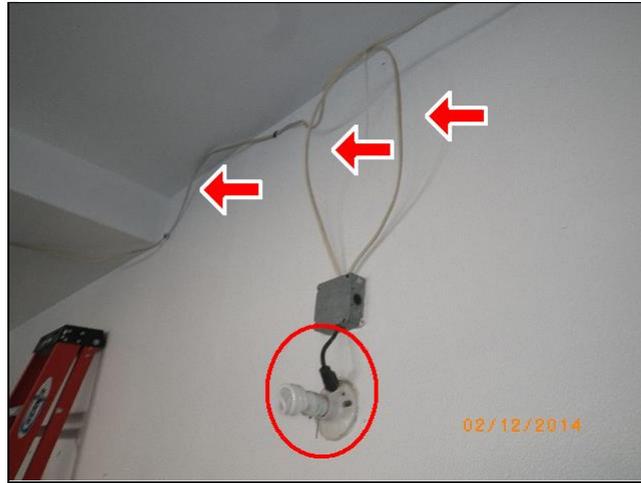
7.3 Item 1(Picture)

7.3 Improper light fixture wiring along with improper splicing as well as exposed and or unprotected wiring was noted in the garage. This is a safety / hazard. Correction is needed by a licensed electrician.

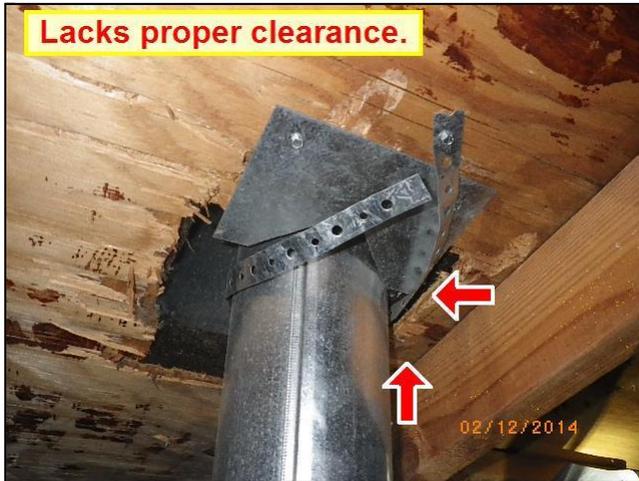
8.5 Item 1(Picture)

- Gas line to both of the heating systems in the attic area lack proper support. This is a safety hazard / concern. Repair is needed by a licensed HVAC contractor or licensed plumber.
- Vent pipe to heating system to the upstairs area lacks proper clearance from combustible material. This is a safety hazard / concern. Repair is needed by a licensed HVAC contractor or licensed plumber.

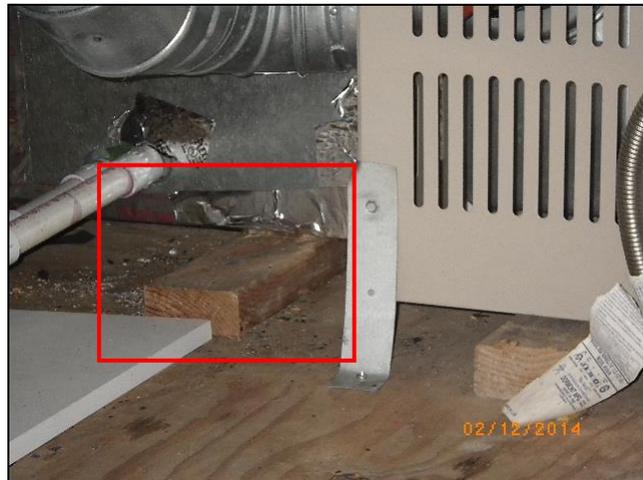
8.8 Item 1(Picture)

- Both of the A/C units were operational. However each unit in the attic area at condenser lack the installation of a catch pan as well as both condensers lacking proper support (pieces of wood used). Recommend further evaluation / correction by a licensed HVAC contractor.
- Please note that due to the size of the home the A/C units may be inadequate for proper cooling to the entire property. Further consultation recommended by a licensed HVAC contractor.
